**SEISMIC BEHAVIOUR OF A SHEAR-CRITICAL  
REINFORCED CONCRETE FRAME:  
AN EXPERIMENTAL AND NUMERICAL INVESTIGATION**

A thesis submitted in conformity with the requirements  
for the degree of Masters of Applied Science  
Graduate Department of Civil Engineering  
University of Toronto

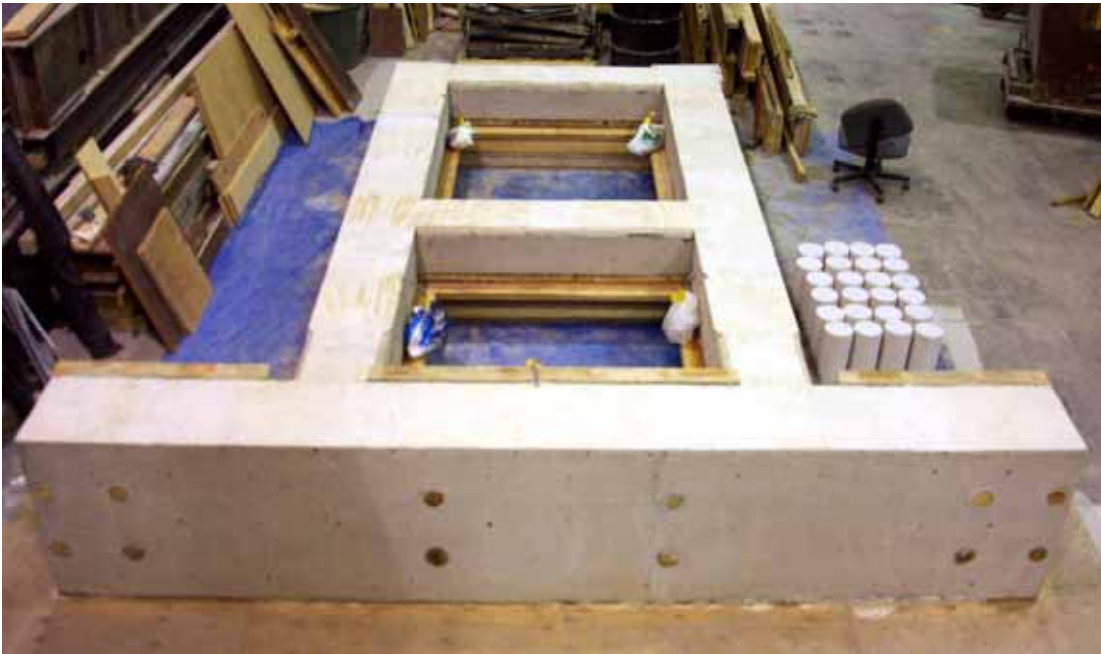
**Figure 3.1 Test Frame after Construction and Casting**

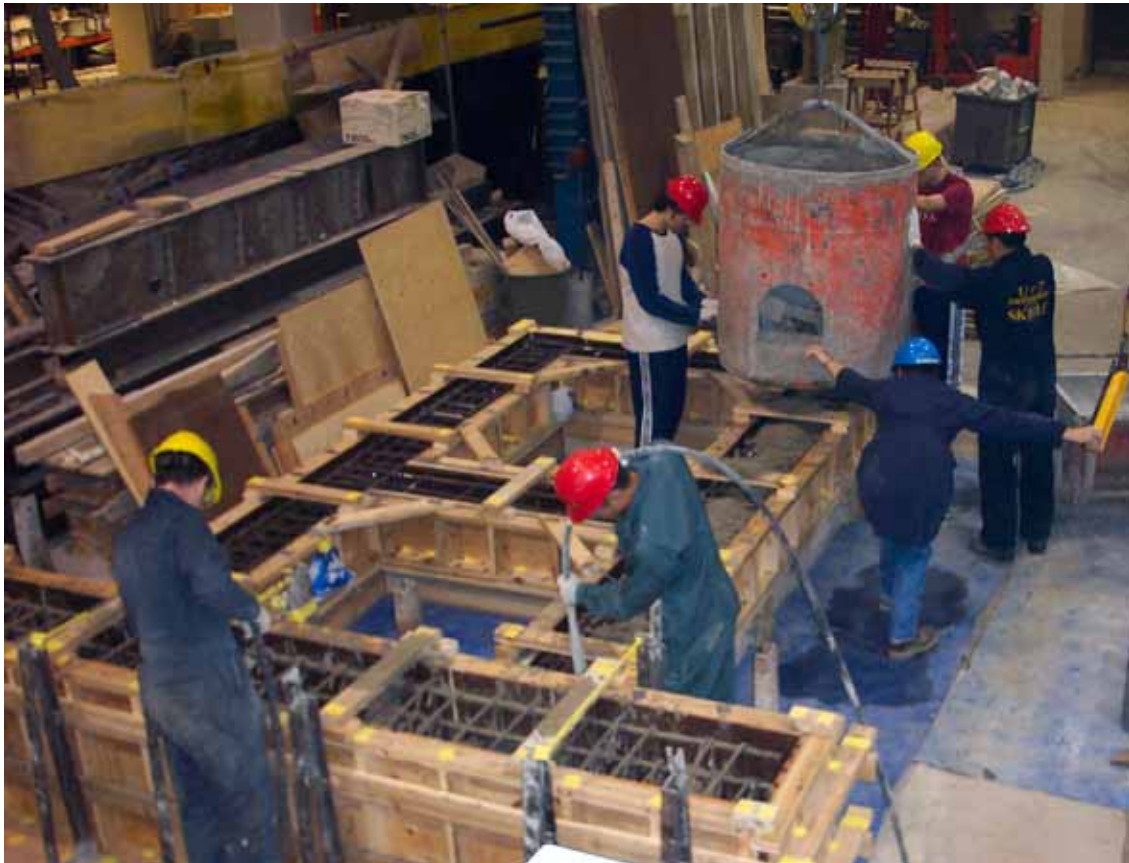
reinforcement. The concrete surface was leveled and finished with trowels. Two hours after casting, the surface was covered with wet burlap and plastic to promote moist curing. The burlap was kept wet for 10 days. In addition to the test specimen, 30 cylinders (150 mm in diameter and 300 mm in height) and four modulus of rupture moulds (152 x 152 x 508 mm) were cast to obtain standard material property data.

**Figure 3.9 Casting of Test Frame**

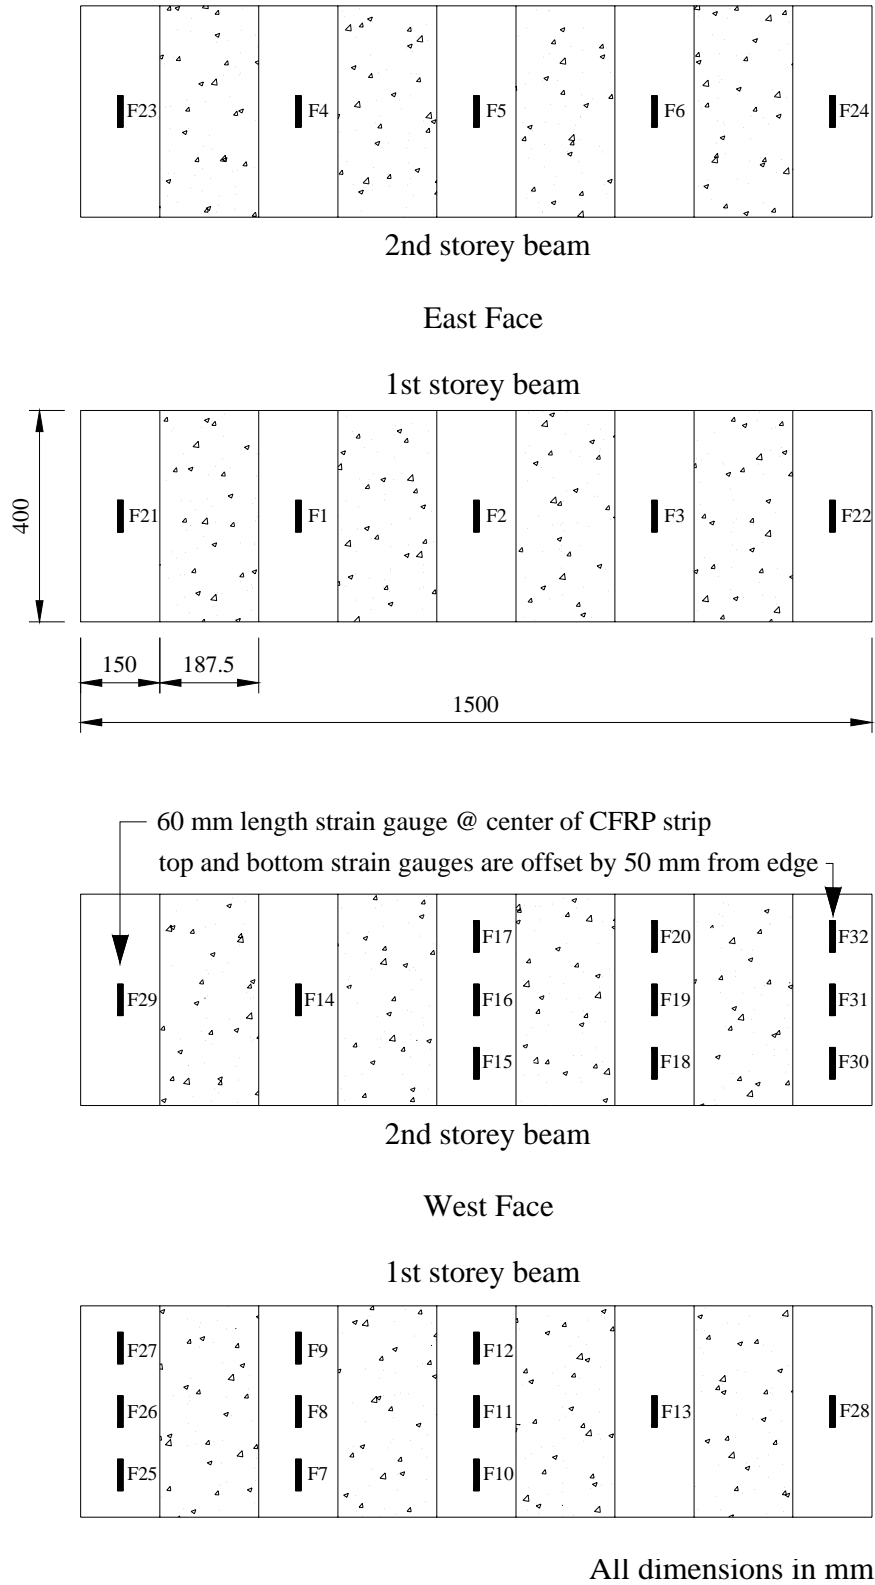
**Figure 3.17 CFRP Strain Gauge Layout**

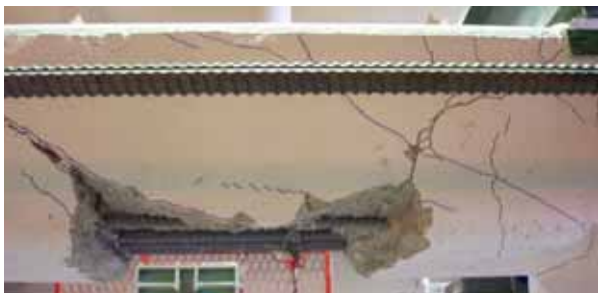
Second-storey Beam: East Elevation

**Figure 3.19 Repair: Chipped Beams**

the vertical load was held constant through out. Refer to Figure 3.19 to Figure 3.23 for photographs of the repair process.

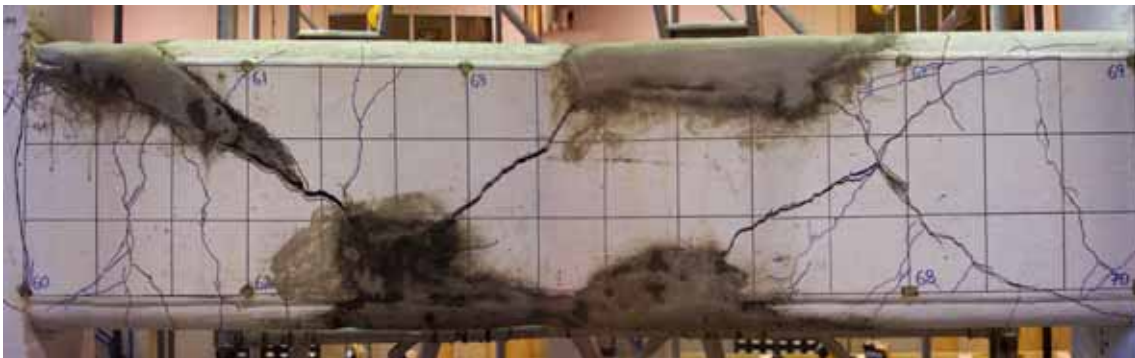
Second-storey Beam: East Elevation

First-storey Beam: West Elevation

**Figure 3.20 Repair: Grouted Beams**

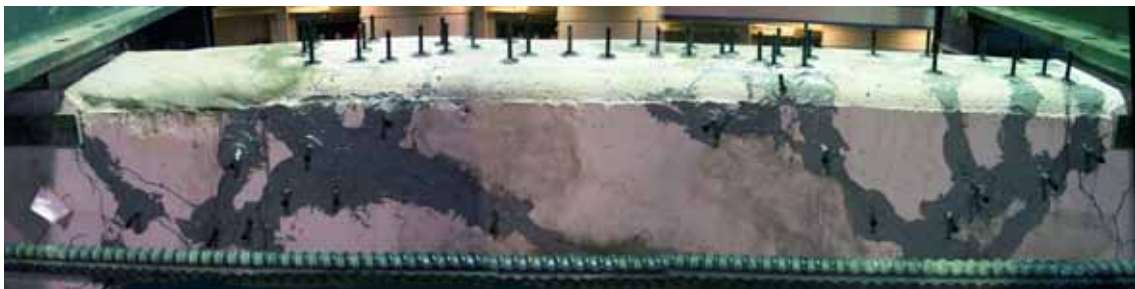
Second-storey Beam: East Elevation

First-storey Beam: West Elevation

**Figure 3.21 Repair: Epoxy Injected Beams**

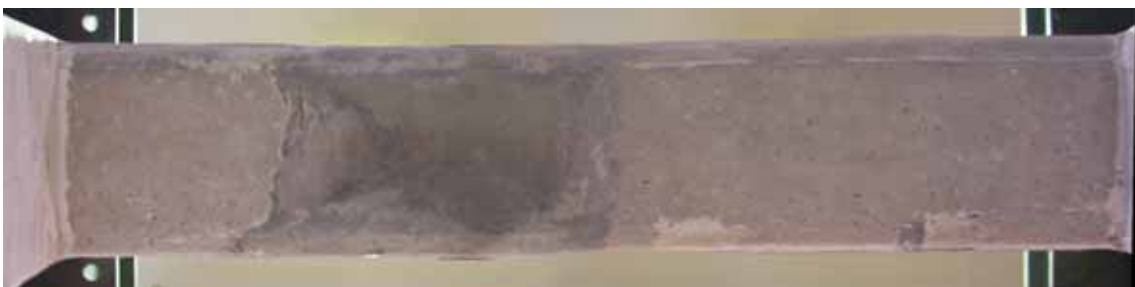
Second-storey Beam: Bottom View

**Figure 3.22a Repair: Pre-wrapped Beams (Beam2)**

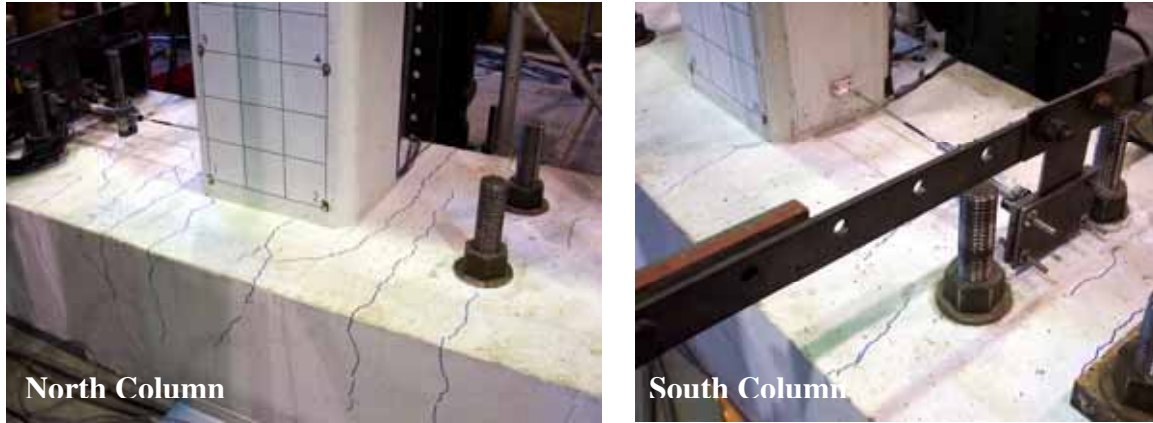
Prior to loading, the frame was examined for cracks that may have developed from shrinkage or post-tensioning of the frame base. The frame did not exhibit any shrinkage cracks; however, post-tensioning cracks on the base were evident, particularly near the two columns where the anchor bolts were concentrated (Figure 4.2). These cracks were caused by undulations and bumps present in both the strong floor and frame base. Even though metal shims were inserted along the edge of the base to reduce the unevenness, gaps within the centre of the base were still present. The cracks were at most 0.1 mm wide and were superficial in nature. The base did not suffer any noticeable damage throughout the duration of testing, except during the last load cycle in Phase B. Even then, the base remained structurally sound.

**Figure 4.2 Initial Conditions at Column Bases**

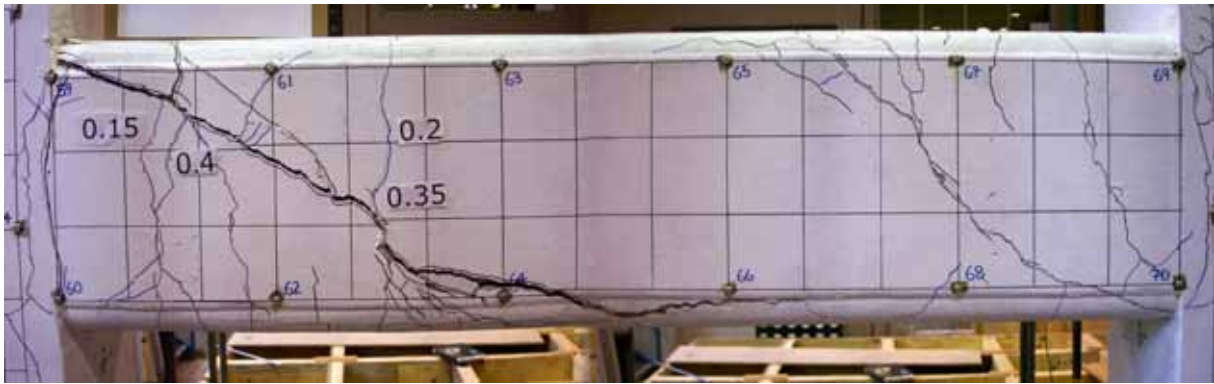
**Figure 4.10 Frame at Load Stage 19**

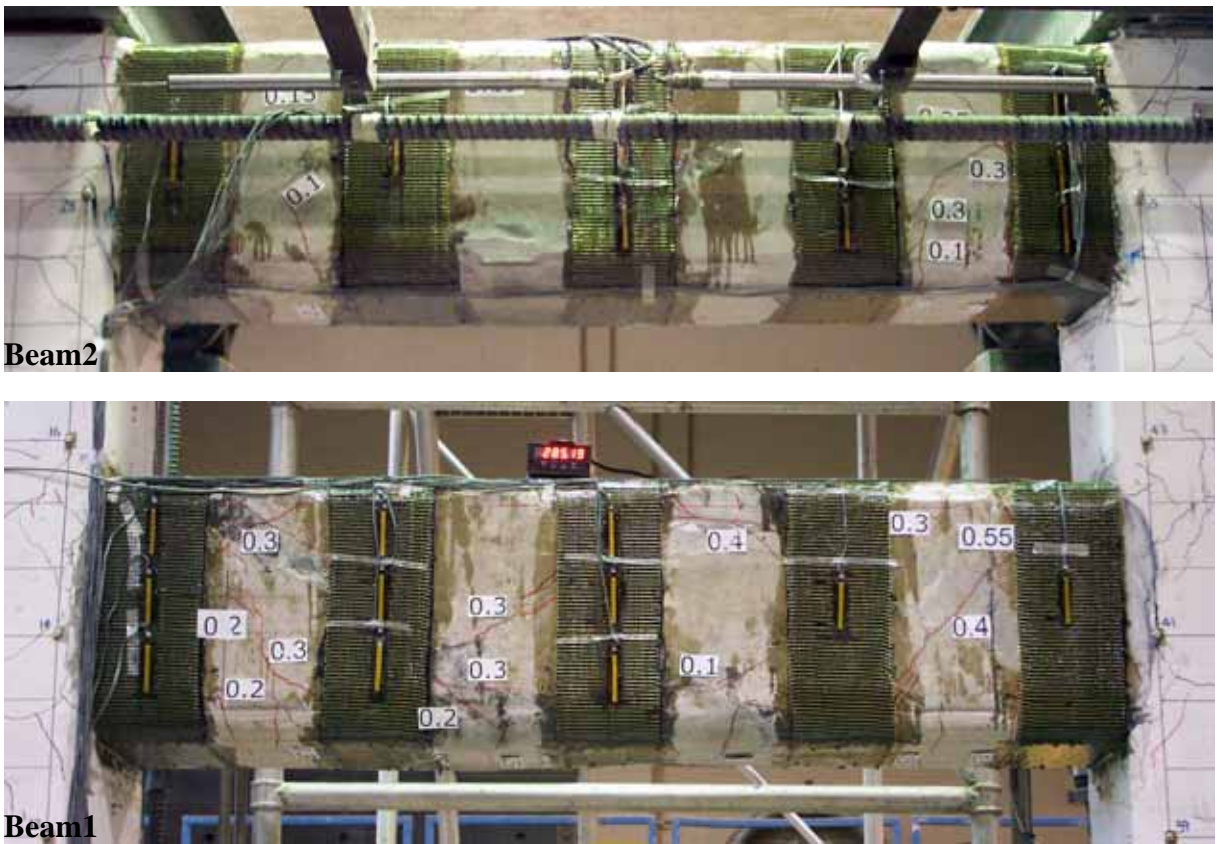
**Figure 4.17 Frame at Load Cycle 4 ( $-1.0 \Delta_y$ )**

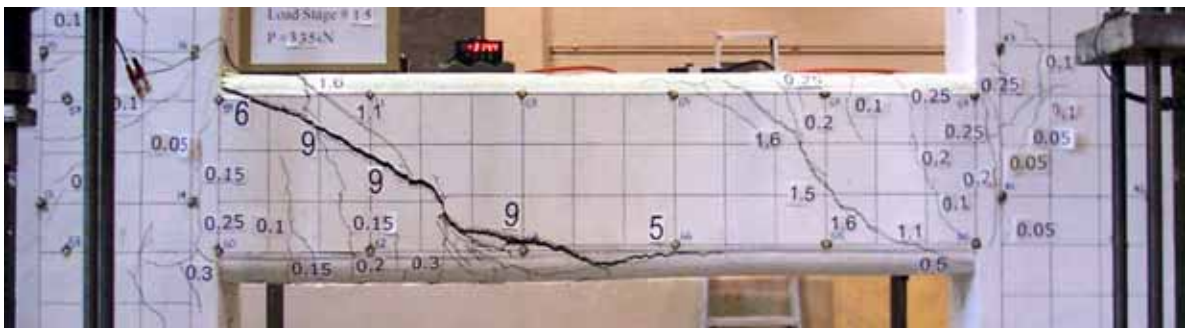
**Figure 6.17 Beam Crack Pattern at +40 mm of Top Storey Deflection**
